Microbial water quality in clean water tanks following inspection and cleaning

Publication date:
2014

Citation (APA):
Christensen, S. C. B., Esbjørn, A., Mollerup, F., & Albrechtsen, H-J. (2014). *Microbial water quality in clean water tanks following inspection and cleaning*. Poster session presented at 9th Nordic Drinking Water Conference, Helsinki, Finland.

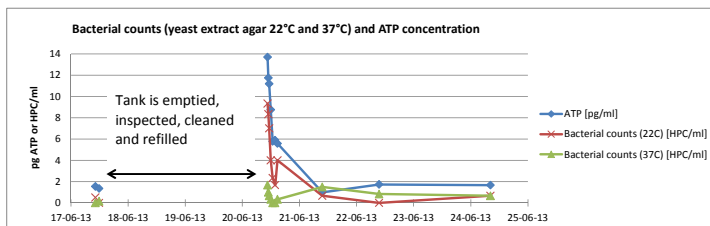
Concentration of ATP and bacterial counts [yeast extract agar, 22 and 37°C] in water leaving clean water tank from the main water works at VCS Denmark

Bacterial counts [yeast extract agar, 22°C] increased slightly after cleaning of the tanks, but did not exceed guideline values at any point during the investigations. Immediately after start-up, a maximum of 10 CFU/ml (Colony Forming Units) were measured in both tanks, and after less than

24 hours the concentrations were below 1 CFU/ml in both tanks. The low concentrations were maintained the following days. Bacterial counts [yeast extract agar, 37°C] were below 2 CFU/ml at all times.

To include bacteria not normally quantified by traditional methods, such as plating, we included ATP (Adenosin-Tri-Phosphate) measurements of the water. ATP is present in all living bacteria. ATP concentrations in the water immediately after start-up were high compared to the concentration of culturable bacteria which may indicate that bacteria from the sand filter e.g. nitrifying bacteria, which normally grow on substrates not present in the agar, were present in the water.
